December 1981

THE STREAMBANK EROSION CONTROL
EVALUATION AND DEMONSTRATION ACT OF 1974
SECTION 32, PUBLIC LAW 93-251

Appendix H - Evaluation of Existing Projects

Volume 1 of 2

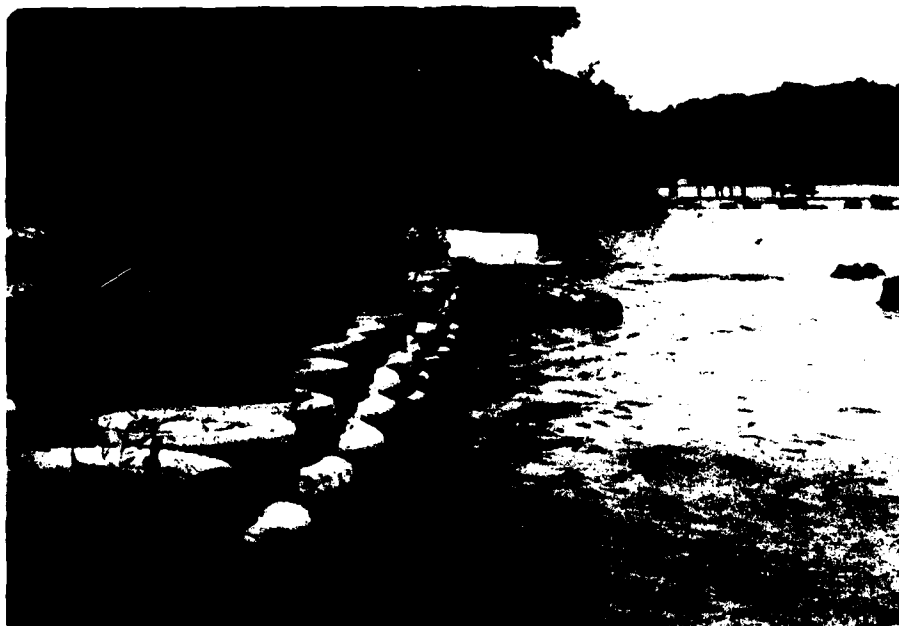
Exhibit 2. Stone-filled tire revetment constructed
by property owners (successful)

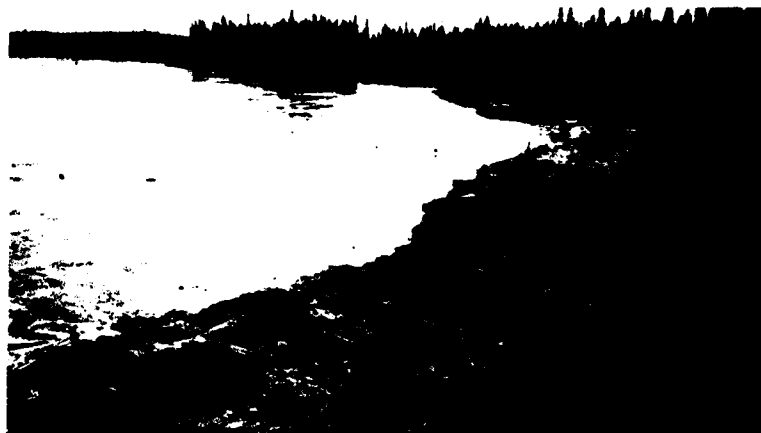
5 May 1979, discharge is 55,000 cfs, slumping and erosion of riverbank on downstream end, ice revetment still in place on upstream end

Exhibit 3. Ice revetment, Tanana River, Alaska (failure)

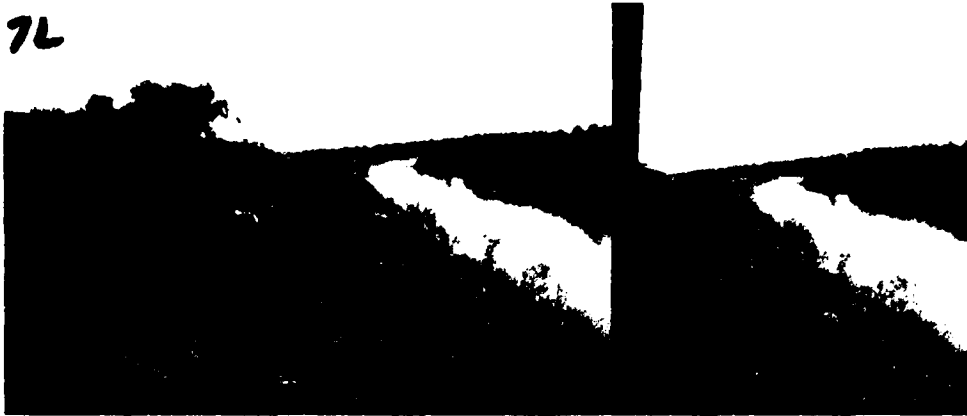
Section 1. Standard Trenchfill Riprap - Looking Downstream

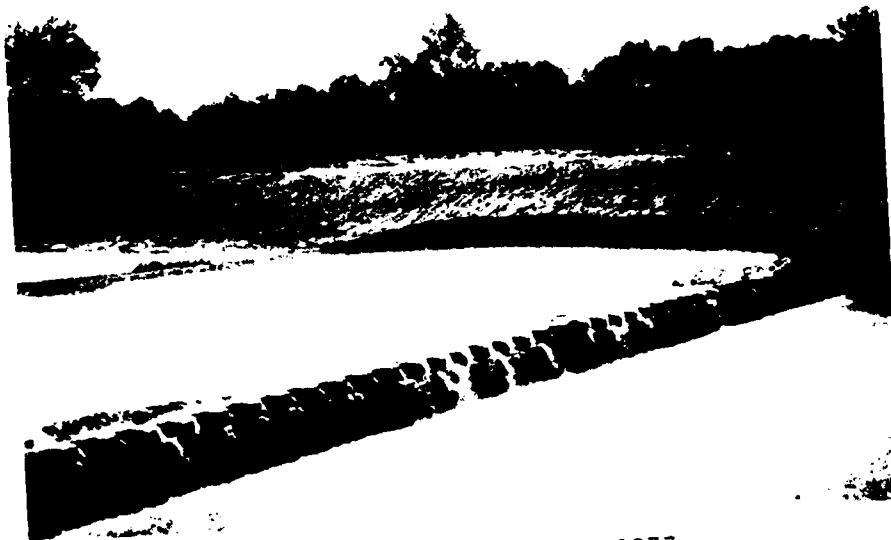
AFTER CONSTRUCTION MAY 1977
Weir 4 Upstream Bank Sloughing

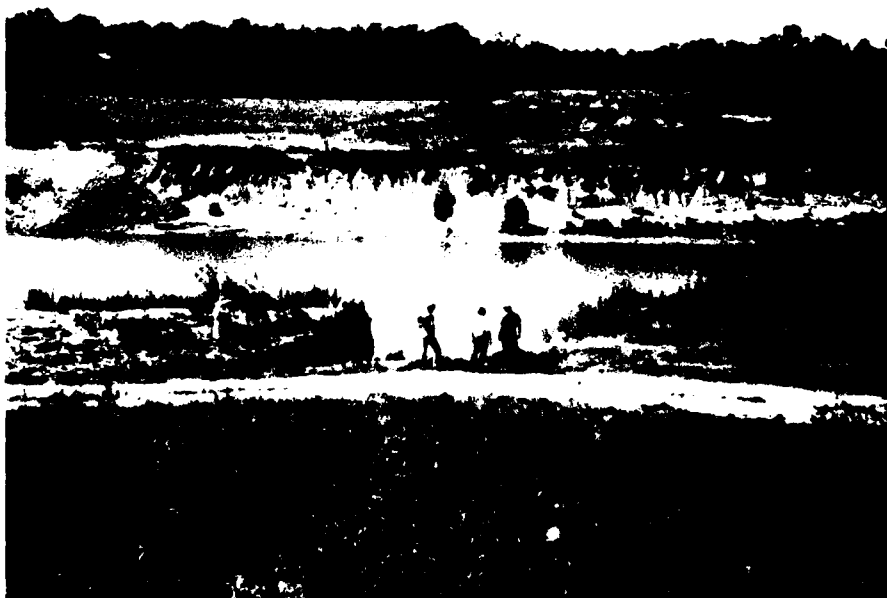
ERODED BANK DOWNSTREAM OF WEIR DUE TO OVERBANK RUNOFFS

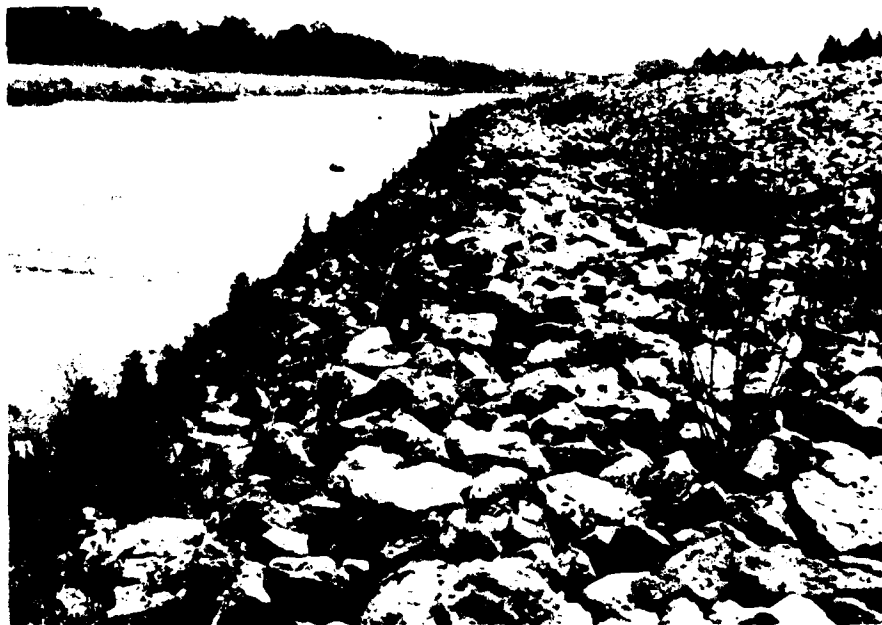
A team consisting of personnel from MRD and MRK conducted the 6th Periodic General Inspection of Milford Dam in May 1981. As part of this inspection, the outlet channel riprap was examined. The team found the rock protection on the channel side slopes was performing satisfactorily, Figure 6, even though the streambed had degraded nearly 6 ft. Progressive armoring was developing over the entire length of the channel bed, and the upstream one-half to two-thirds of the channel bed was armored to the point where no additional degradation was expected. No areas of weakness in the toe protection were noted during this inspection, Figure 7.

Figure 6. Republican River at Milford Dam Outlet Channel, Kans. General appearance of the middle reach of the outlet channel at the time of the July 1981 inspection.

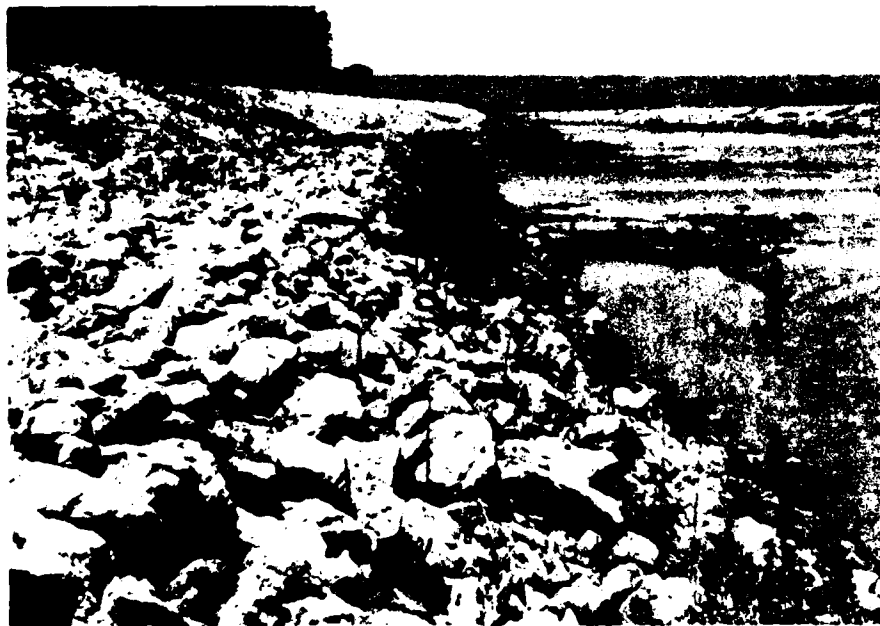
Figure 7. Republican River at Milford Dam Outlet Channel, Kans. Typical view of the revetment toes as of July 1981. Note break in slope between the blanket and the slope to the water.

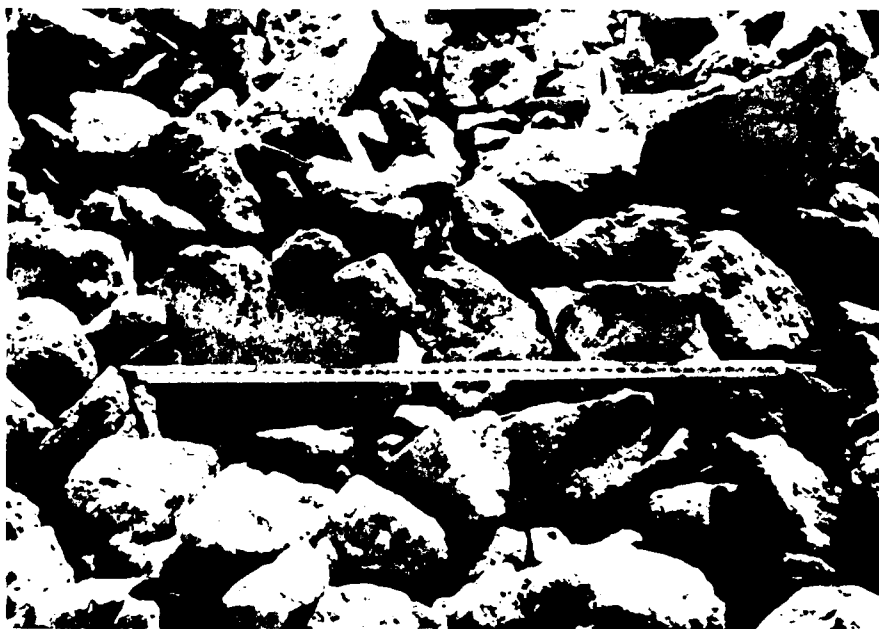
Figure 10. Republican River at Milford Dam Outlet Channel, Kans. There was good coverage of rock on the slope below the 30-in.-thick horizontal blanket at the time of the July 1981 inspection (Test Section 4).

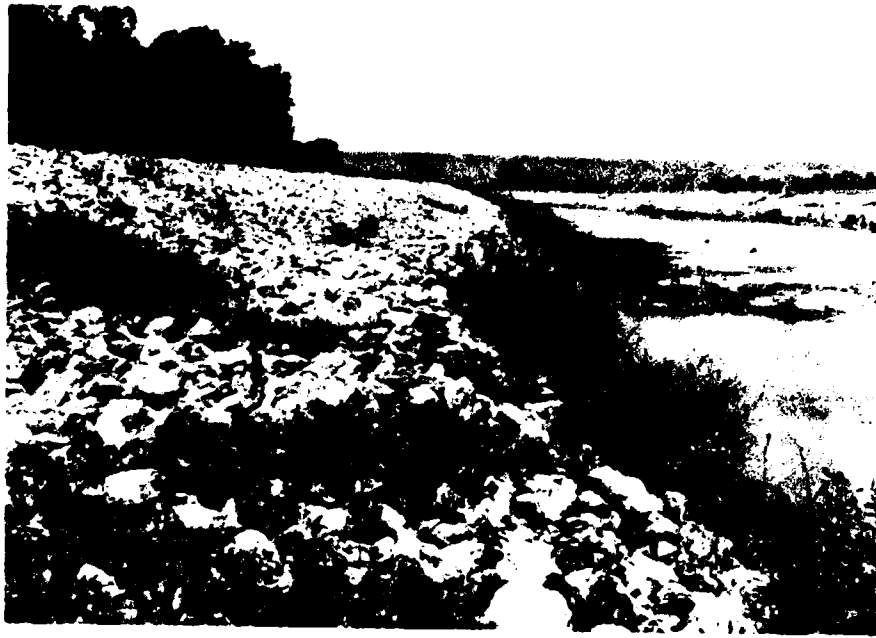
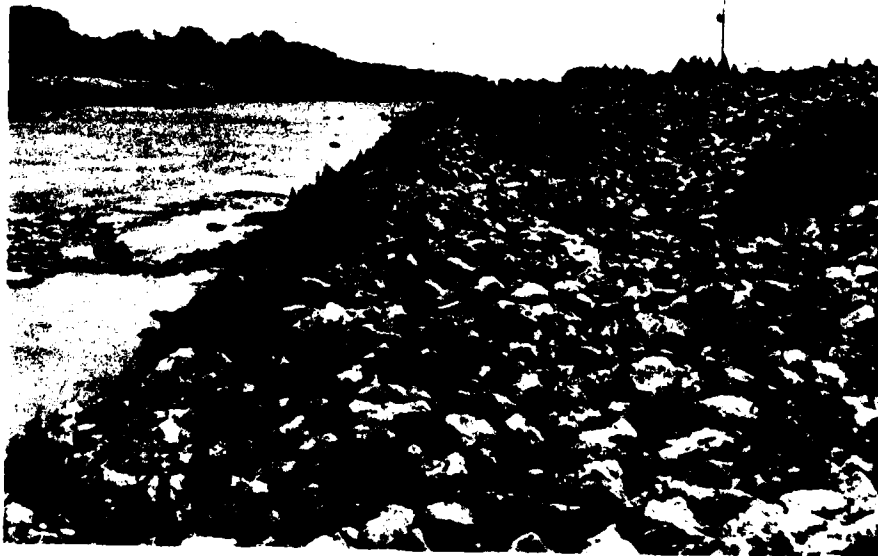
Figure 12 shows upstream and downstream views of the revetment in the outlet channel. The project is performing as designed, Figures 4 and 5. No apparent failures have occurred with the exception of minor areas where stone has been displaced and exposed the bedding material, Figures 8 and 9.

Figure 12. Republican River at Milford Dam Outlet, Kans.
Upstream and downstream views of the outlet channel revetment.
(July 1981)

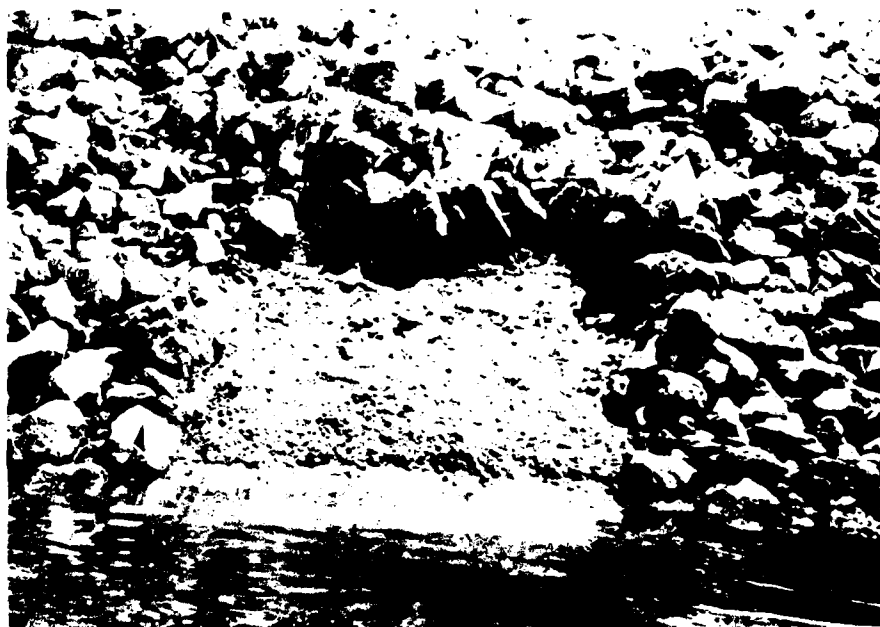
In August 1980, five test areas of stone were excavated and graded, Figures 13 and 14. The results showed the median size of the stone to be 22 pounds against the 25 pound median specified during construction and maximum size of 160 pounds against 150 pound maximum specified. This could indicate some breaking down of stone in the mid-range of the original gradation. The stone coverage in the test sections varied from an average of 1.5 to 2.25 rock diameters. Overall the revetment is performing as designed.

Figure 13. Republican River at Milford Dam Outlet, Kans.
Test area sampled in August 1980 in Test Section 3.

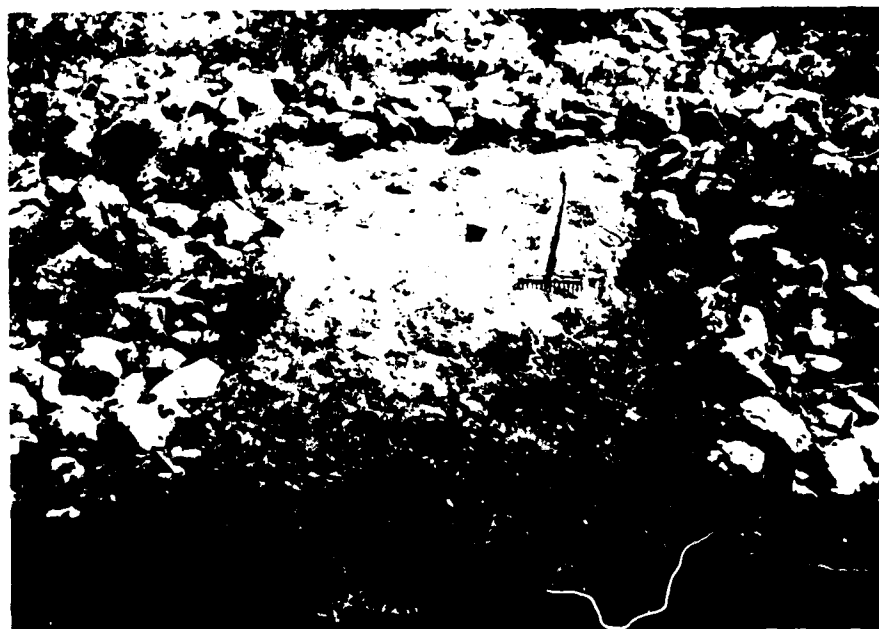
Figure 14. Republican River at Milford Dam Outlet, Kans.
Test area sampled in August 1980 in Test Section 4.

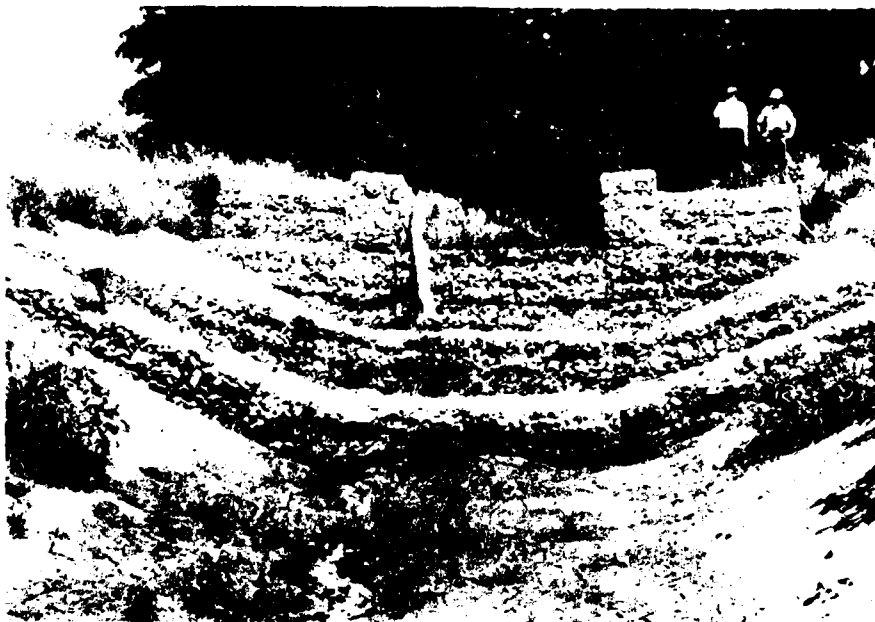
Figure 4. Little Blue River at Independence, Mo. Gabion drop structure to control overbank drainage.

However, as a result of uncontrolled overbank drainage, clay blanket erosion occurred at some locations, Figure 3. These areas have been repaired by the construction of two gabion drop structures, Figure 4, and a number of grouted gutters, Figure 5. Several areas of erosion of the clay blanket on the high flow berm will be repaired by a series of low rock dikes across the berm.

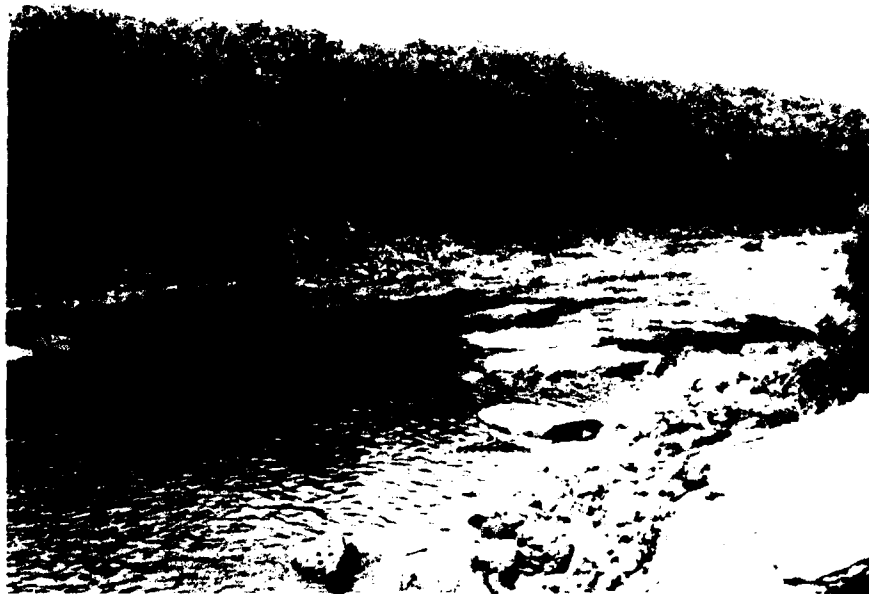
The Waterways Experiment Station (WES) inspection team visited this site on 21 September 1978. Although high flows had undercut the Fabriform at several locations, resulting in pieces breaking off at the toe, Figure 10, or subsidence of sections, Figure 11, most of the revetments were generally in good condition, Figure 12. During the March 1979 flood (2,000 c.f.s. maximum daily flow), the drop structure, Figures 1 and 5, was undercut and failed, Figure 13. In an attempt to protect the upstream reach, a temporary dam was constructed at the site of the structure; the construction proceeded from the right bank across to the left bank. This caused a concentration of flow on the left bank and against the Fabriform mattress before closure was made. As a result, nearly all of the fines were washed out of the rock fill under the Fabriform in this vicinity, creating a "pipe" under the Fabriform that was parallel to the streamflow. This resulted in a relatively large erosion hole on the left bank under the Fabriform. As a result, the undercut Fabriform had to be broken out and rock fill placed in the void.

Figure 10. 102 River (East Fork) at Bedford, Iowa. High flows undercut the Fabriform mattresses at several locations resulting in parts of the revetment breaking off and being swept into the center of the channel.

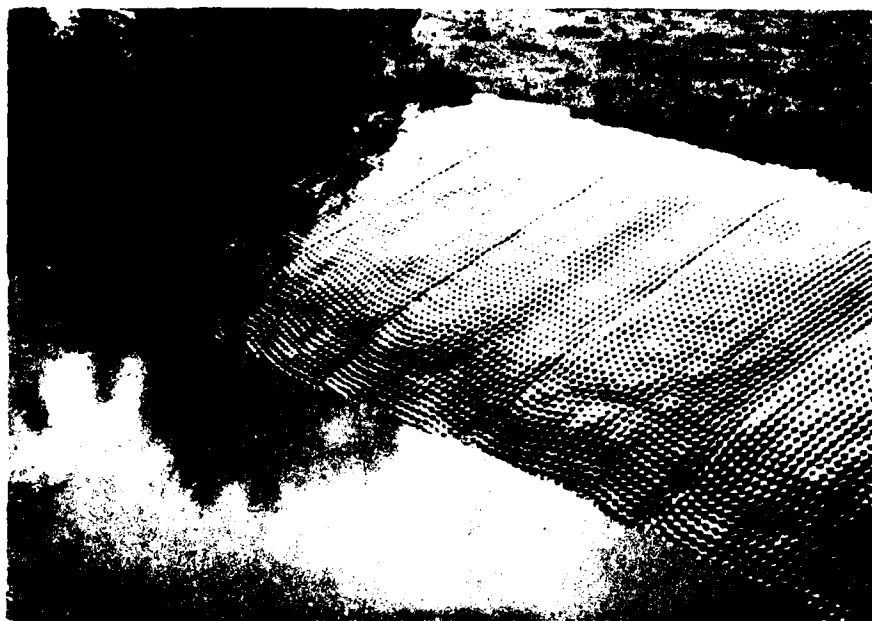
Figure 12. 102 River (East Fork) at Bedford, Iowa. At the time of the 1978 inspection visit, most of the Fabriform revetment was intact. This view shows the mattress downstream from the State Street Bridge.

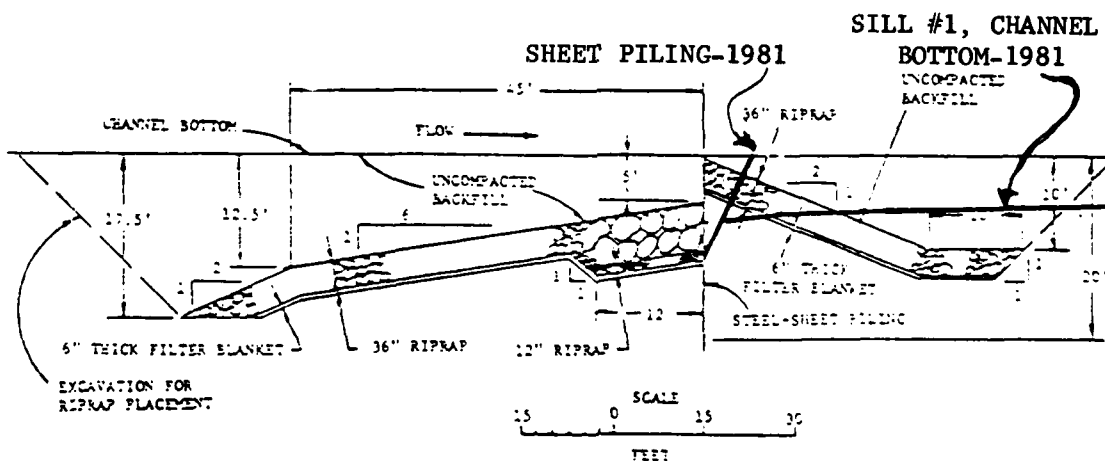
Figure 5. Floyd River at Sioux City, Iowa. Center-line view of sheet piling and rock sill at Sta. 2+90. Results of April 1981 survey superimposed.

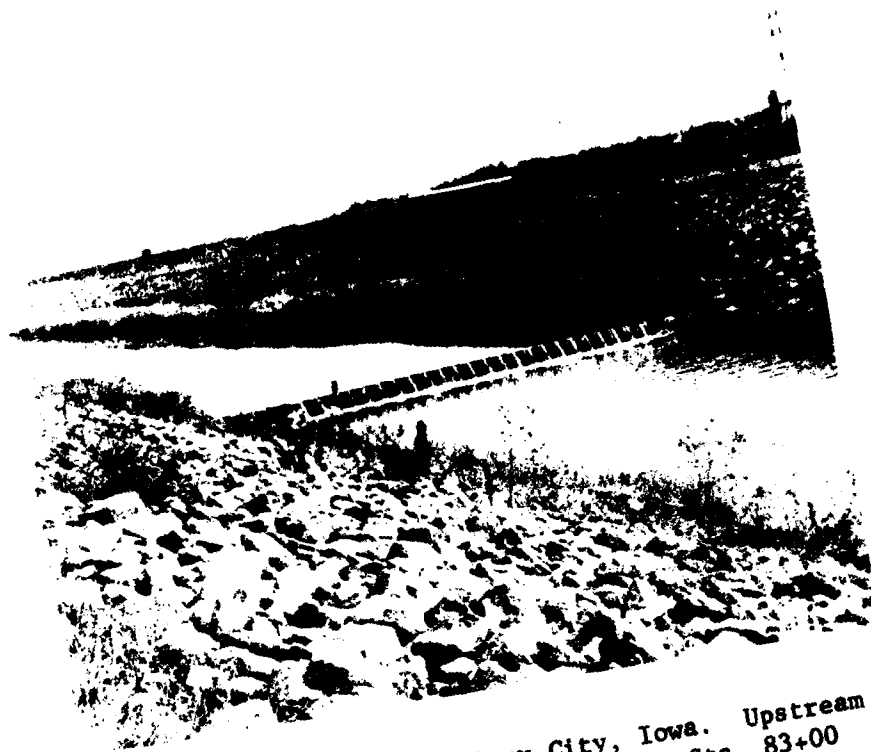
The riprap downstream of sill No. 5 at station 83+00 has been displaced to a depth of 7 feet below the crest of the sheet-piling, Figures 6 and 7. There has been no deformation of the sheet-piling. The other three sills were in excellent condition and overall the project is functioning as designed.

Figure 6. Floyd River at Sioux City, Iowa. Upstream view of sheet piling and rock sill #5, Sta. 83+00

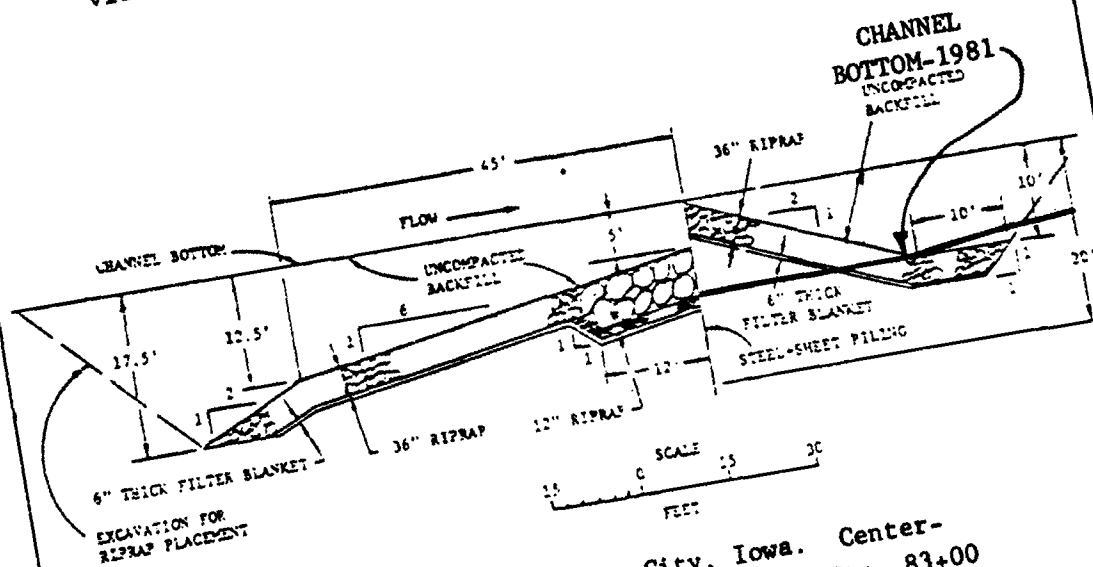
Figure 7. Floyd River at Sioux City, Iowa. Center-line view of sheet piling and rock sill #5, Sta. 83+00 Results of April 1981 survey superimposed.

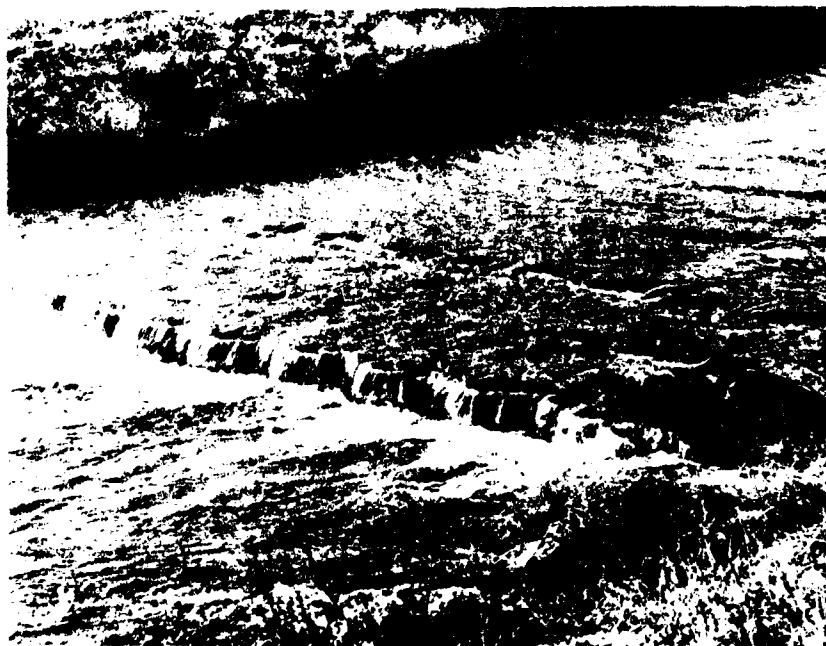
Figure 4. West Fork Ditch at Onawa, Iowa. Sheet-pile crest at sill 3 (March 1981)
